Manhole Inspection Summary

Manhole # S21AA2006MH

Insp Date: **11/21/06 8:42 AM**

Location Address: **5509 SABINA AVE**

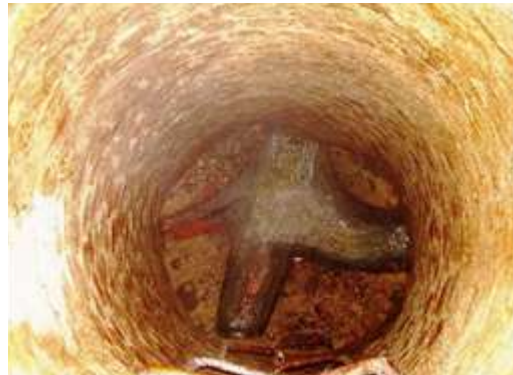
Top View

Corroded steps. Bench debris.

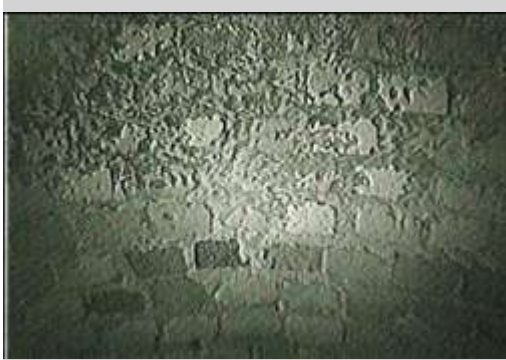
Defect

Barrel infiltration.

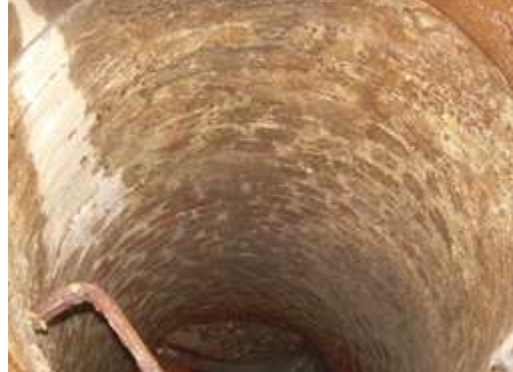
Defect

Frame leaks. Corroded steps. Adjustment infiltration.

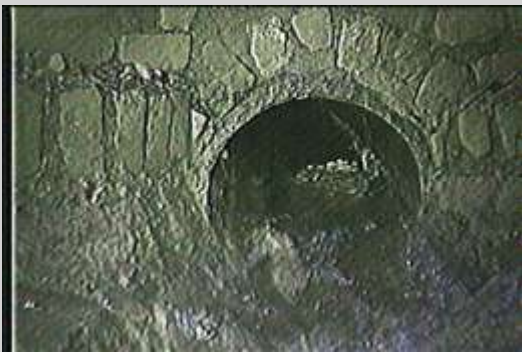
12 in. Circular Gravity Sewer Pipe Out @ 12 O'Clock

Deposits: ☐ None ☐ Mud ☐ Sludge ☒ Debris ☒ Grease

Infiltration: **Evidence** Pipe Seal Cond: **Unknown**

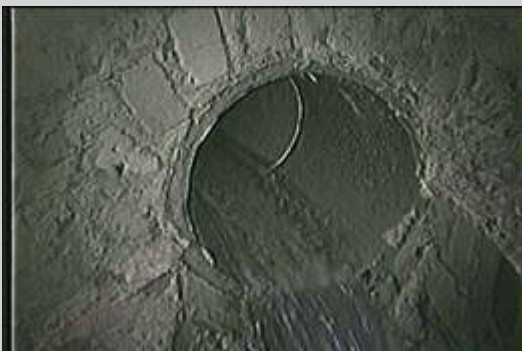
12 in. Circular Gravity Sewer Pipe In @ 3 O'Clock

Channel cracks.

Infiltration: **Evidence** Pipe Seal Cond: **Cracked**

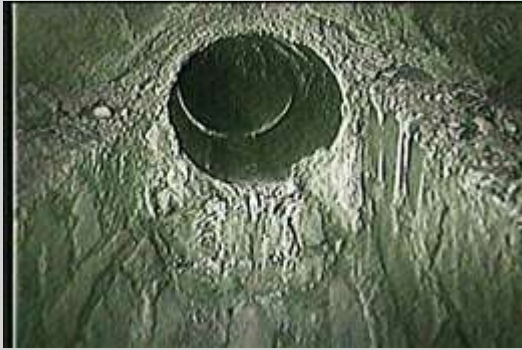
Pipe In @ 6 O'Clock

Infiltration: **Evidence** Pipe Seal Cond: **Unknown**

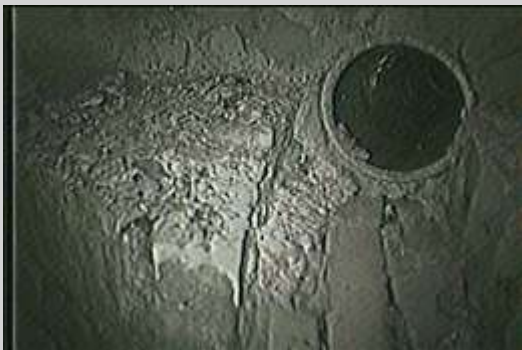
Pipe In @ 8 O'Clock

Bench and Channel deterioration.

Infiltration: **Evidence** Pipe Seal Cond: **Cracked**
